# Technical Service Bulletin

**NUMBER:** 03-03-99

Noisy Front Propeller Shaft Rear Constant Velocity Joint

1999 (WJ) Grand Cherokee

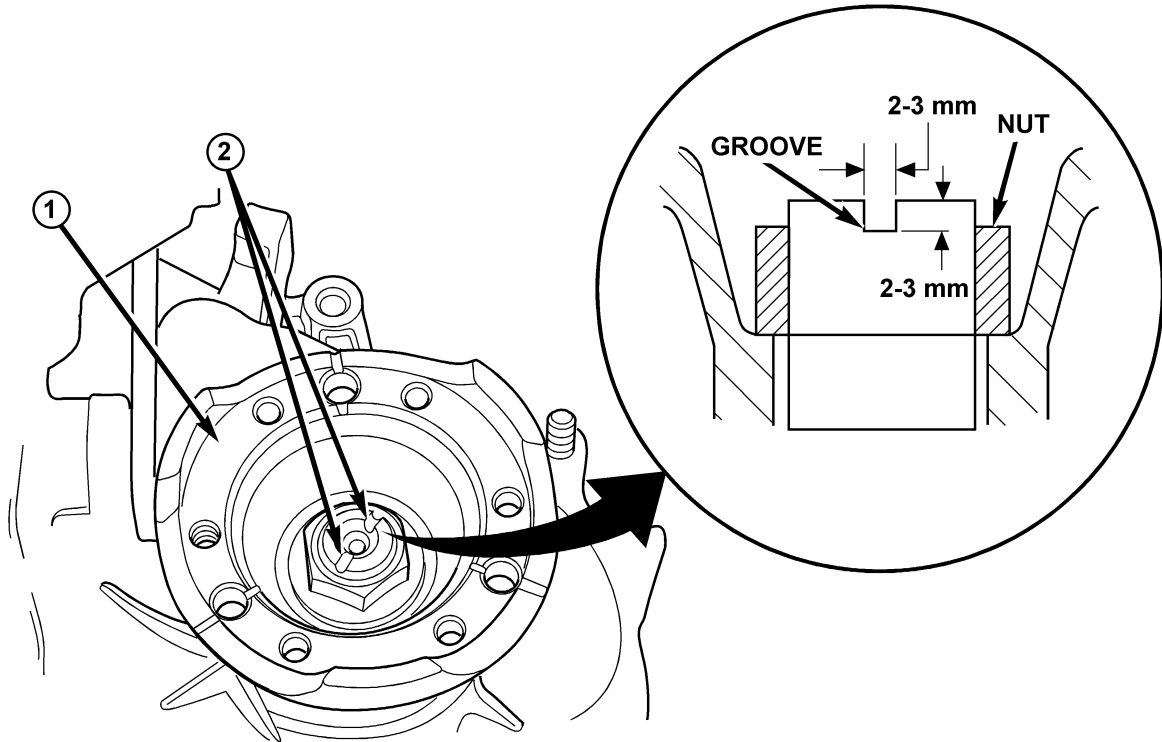
Figure 1

The condition may be the result of an interference fit between the back of the rear CV joint and the end of the transfer case front output shaft. This interference fit may cause the vent hole on the back of the rear CV joint to become blocked (sealed over). If the vent on the joint becomes blocked, it may cause pressure to build within the joint which may result in damage to boot of the rear CV joint.

1 - COMPANION FLANGE, TRANSFER CASE FROM OUTPUT SHAFT
---

2 - VENT CHANNEL (3mm WIDE BY 3mm DEEP)
---

1. Remove the front propeller shaft from the vehicle.
2. With a suitable grinder, grind a vent channel (groove) across the end of the transfer case front output shaft. The vent channel should be 2 - 3 mm (0.118 inches) wide and a depth of 2 - 3 mm (0.118 inches) (Figure 1).
