# TSB 21-08-99

## "Buzz", "Whining", Or "Moaning" Like Noise From A Cold Transmission When Reverse Is Selected.

**Date:** April 30, 1999

**Models:** 1996 - 1999 (BR/BE) Ram Truck

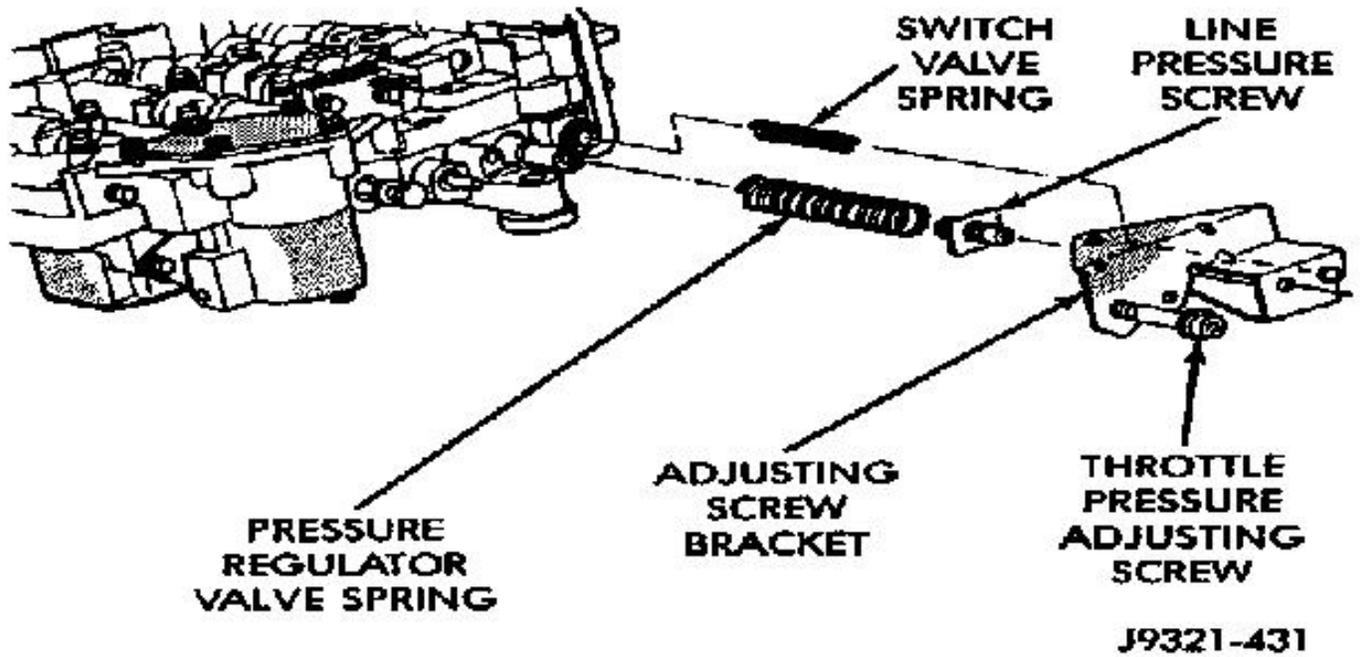
Some vehicles may exhibit an intermittent noise from the transmission when reverse gear is selected. This noise has been described as a "buzz", whining", or "moaning" like noise. The noise is most noticeable when transmission fluid temperature is below 38° C. (100° F.). The condition is caused by a resonance of the transmission regulator valve system. Other items may cause regulator valve resonance, including air ingestion into the valve body or out of specification parts. These two items may be the result a possible cracked pump housing, a torn pump gasket, an under filled transmission, a restricted fluid filter or cooler flow, or an out of specification valve and/or valve body. You should remember these additional items / components when you perform your diagnosis.

1. Following the procedures in the applicable service manual, remove the valve body from the transmission (Refer to Group 21 of the appropriate Service Manual - TRANSMISSION AND TRANSFER CASE - AUTOMATIC TRANSMISSION section - REMOVAL AND INSTALLATION).
2. Remove the screws holding the adjusting screw bracket and replace the regulator valve with p/n 04130169 (Figure 1). Install the adjusting screw bracket. Verify and adjust, if necessary, both the line pressure and the throttle pressure settings by following the procedures in the service manual (Refer to Group 21 of the appropriate Service Manual - TRANSMISSION AND TRANSFER CASE - AUTOMATIC TRANSMISSION section - ADJUSTMENTS - VALVE BODY)
