**NUMBER:** 25-001-03

**GROUP:** Emissions

Duty Cycle Purge Solenoid Causes A Ticking-Like Sound From Engine Compartment

2002 - 2004 (WJ) Grand Cherokee (Domestic Markets Only)

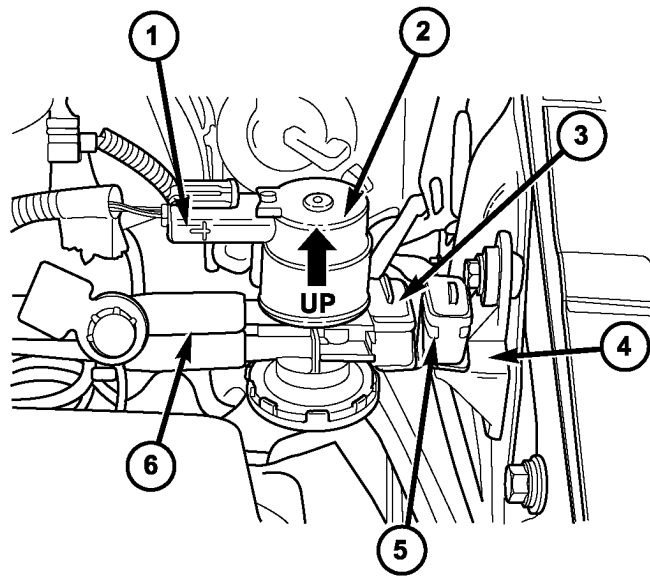
**Fig. 1 DCP SOLENOID & ISOLATION BRACKET**

The customer while sitting in the passenger compartment may notice a ticking-like sound when the engine is idling. The sound may be more noticeable in colder ambient temperatures. Mechanical contact between the DCP solenoid and the body of the vehicle may be the cause of the ticking-like sound.

**NOTE: THE DCP SOLENOID HAS A CORRECT MOUNTING ORIENTATION. THE BODY OF THE DCP SOLENOID IS MARKED WITH THE WORDS "UP" AND "BOTTOM". THE ELECTRICAL SECTION OF THE SOLENOID MUST BE ON TOP WHILE THE DIAPHRAGM PORTION OF THE SOLENOID MUST FACE DOWN.**

2. Remove the DCP solenoid from its plastic body mounting bracket by grasping the DCP solenoid and lifting upward.
3. Note how the rubber bushing is installed to the DCP solenoid before removing the bushing from the solenoid. The original bushing has a wide slot through

the middle of the bushing. Remove the original bushing and install the new bushing with the narrow slot, p/n 53030987.

4. Install the new isolation U-bracket to the plastic body mounting bracket.
5. Install the DCP solenoid (with the new narrow slot bushing) to the isolation U-bracket. Make sure that the DCP solenoid is correctly oriented. (Fig. 1)
6. Install the evaporative vapor lines and the electrical connector to the DCP solenoid.
