NO: 23-14-99

SUBJECT: Door Weather Seal Retention

This bulletin involves installing foam tape on door seal flange to assure proper sealing and retention.

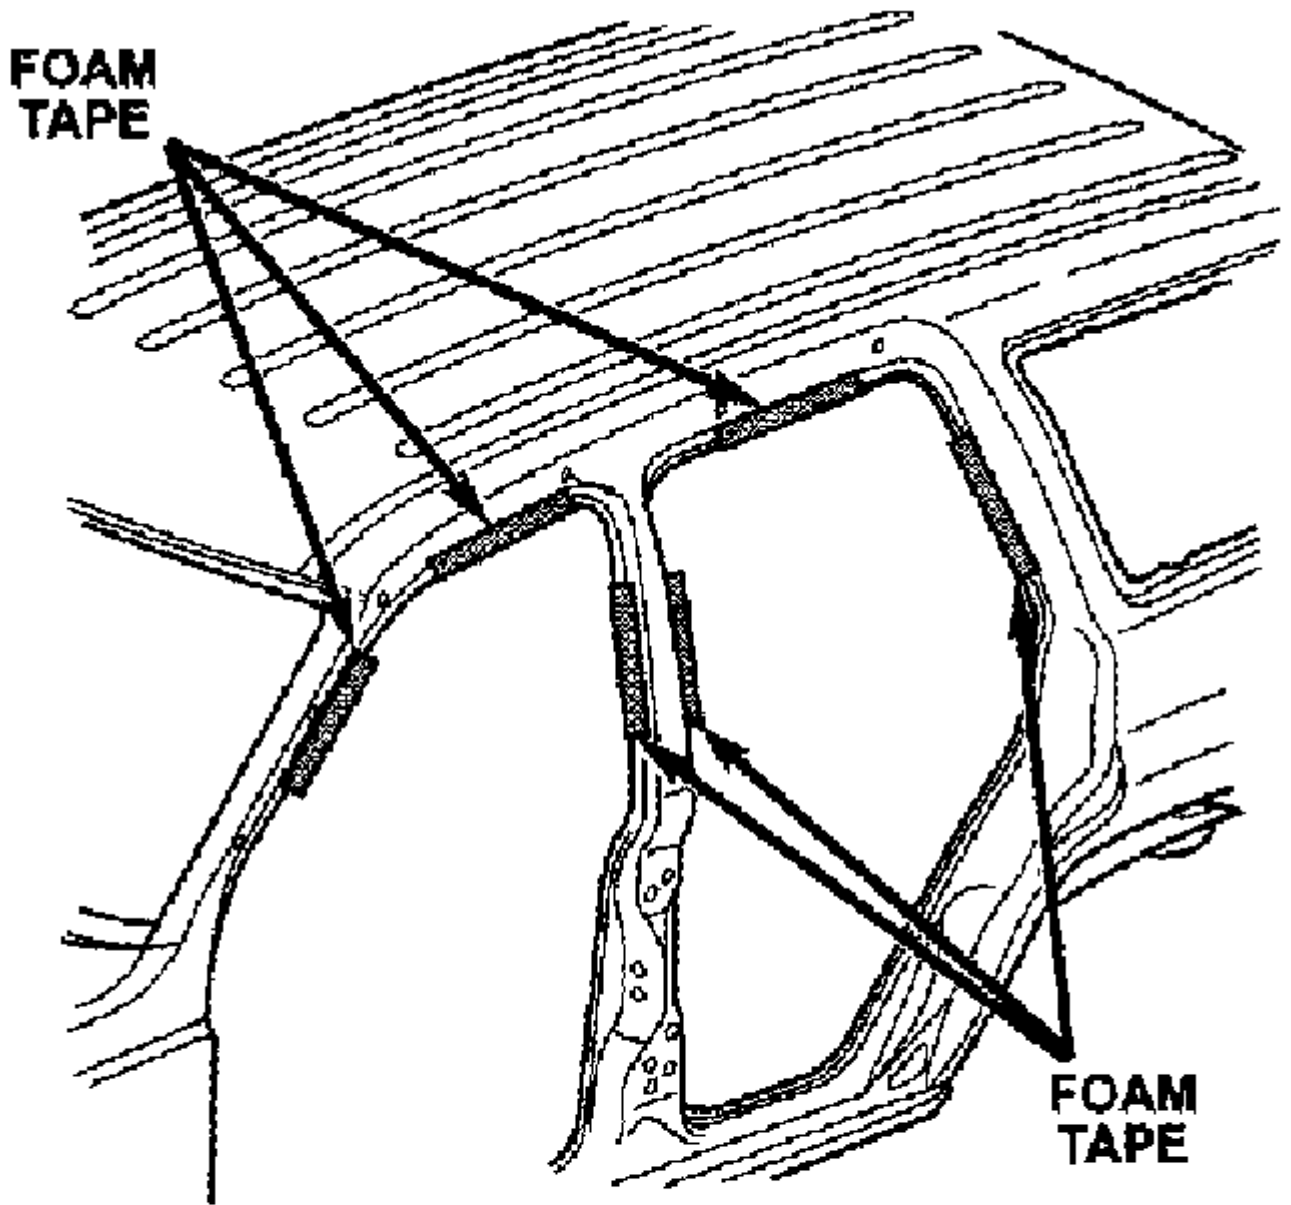
FIGURE 1

The door weather seals may not fit the door flange properly. This can cause loose or sagging door seals and the associated wind and water leaks.

1. Open the door and pull the door seal down away from the flange.
2. Apply three 12-inch strips of foam tape, p/n 04318028, to the flange in the areas shown (see [Figure 1](#)) for each affected door.
3. Install the seal making sure that the seal is fully seated on the flange.
